Ravenscraig Walled Garden

CONDITION REPORT & DEVELOPMENT MASTERPLAN

V.6 September 2017

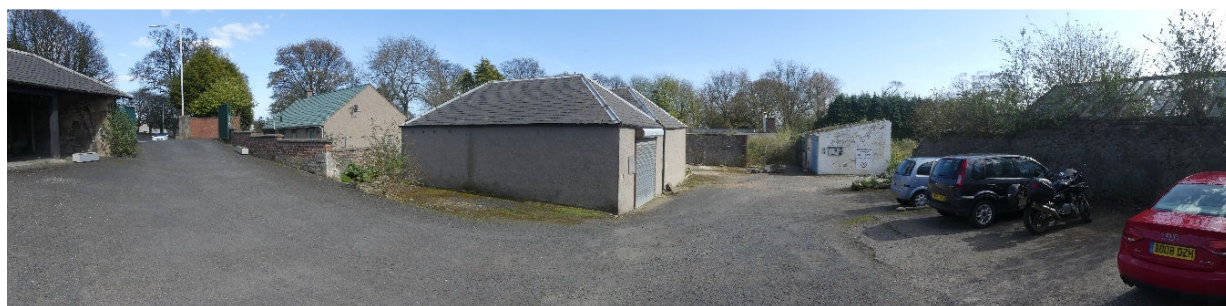
Fig. 13: Entrance area, 2016

Table 3b: Spaces Condition Summary					
Space	Size m ²	Description	Condition		
			Good	OK	Poor
Entrance	800	An irregular public space with buildings in hazardous condition. Not a safe & well-oriented reception space.			
Main Garden	25,000	Well-managed allotments & community growing and wildlife areas, but marred by some derelict areas.			
Courtyard	900	The courtyard is overgrown by plants and contains buildings that are derelict and dangerous.			
Fife Council Yard	120	This area is a functional but unattractive, with an industrial metal fence and several derelict buildings.

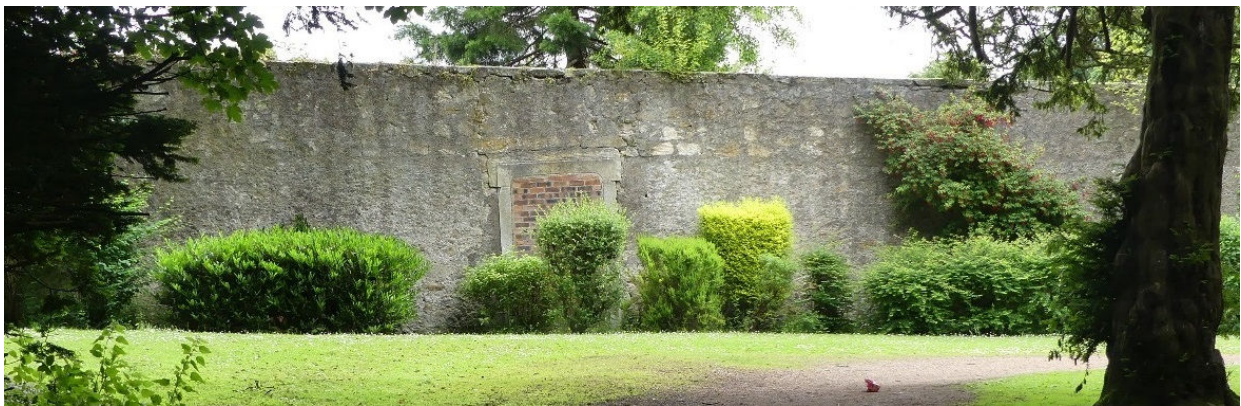
Table 3c: Walls Condition Summary					
Wall	Size, m. (L x H)	Summary description	Condition		
			Good	OK	Poor
North Boundary	240 x 1.7-3	Sandstone coped rubble wall retains 1-2m ground. 1 blocked archway, 1 large crack, largely cement pointed.			
West Boundary	108 x 3-4	Sheltered sandstone coped rubble wall. 2 blocked doorways, some defects, remnants of original harl.			
South Boundary	224 x 2	Low, unattractive rubble wall, concealed by planting. Minor defects, 2 blocked doorways & 1 gateway.			
East Boundary	105 x 0.7-3.5	Rubble in several sections, numerous defects & disused historic gateway. FC service yard entrance.			
Garden East	95 x 3-4	Rubble extended in brick. Derelict buildings abutting. A large section is engulfed in vegetation.			
Courtyard North	30 x 3	Rubble, partly retaining ground. Modern alterations in poor condition.			
FC Yard North Wall	24 x 4	Historic, buildings abutting both sides. Blocked historic gateway to the east.

Fig. 16: West Wall from public park with blocked gateway into main garden, 2016

All the walls should be comprehensively repaired. The brick extensions to the main garden east wall should be removed and its masonry head reinstated. Infilled brick doorways should be reinstated to use, where this would conform with access and security strategies.

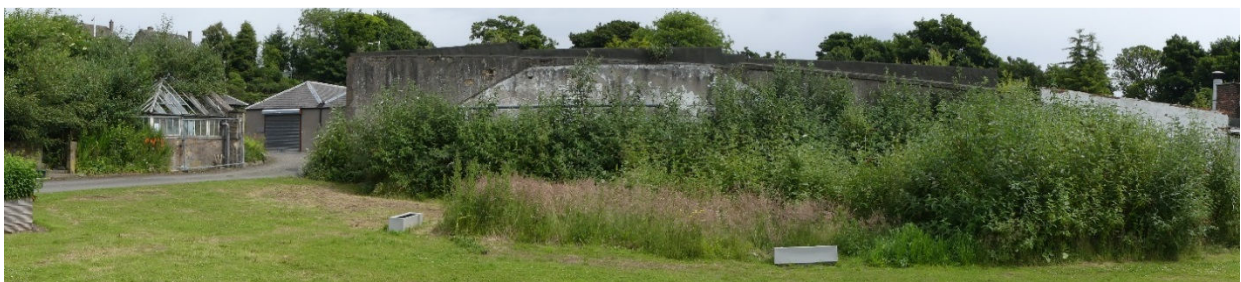
Fig. 17: East wall of the main garden, overgrown and derelict, 2016

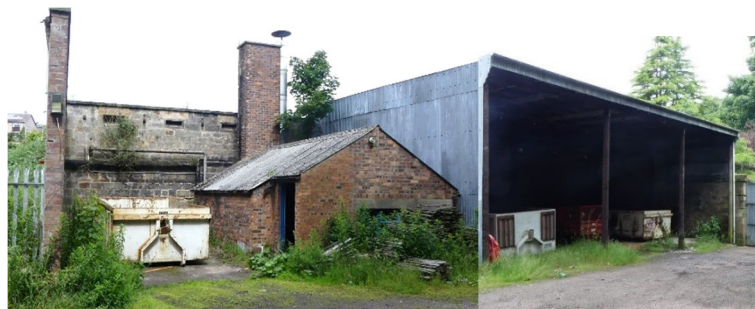
Fig.20: Boiler House & FC Tractor Shed

Table 3d: Buildings Condition Summary					
Building	Size	Description	Condition		
			Good	OK	Poor
1 Potting Shed	150m ²	Now beyond economic repair. Should be demolished.			
2 Greenhouse	–	This building has been demolished since 2010.			
3 Stores	110m ²	Historic masonry, roof partially collapsed. Derelict & hazardous, should be restored to use.			
4 Open Store	60m ²	Historic building in derelict & hazardous condition, some temporary propping. Should be restored.			
5 Office	80m ²	This masonry structure has become derelict and hazardous since 2010, but could be reinstated to use.			
6 Tractor Shed	90m ²	This modern building is in fair condition, but is inappropriate to the site and should be replaced.			
7 Boiler House	20m ²	This modern brick building with sunken floor, is redundant, derelict and should be removed.			
8 Greenhouse	–	This building has been demolished since 2010.			
9 Victorian Greenhouse	150m ²	Deteriorated since 2010, now derelict and dangerous. The masonry base could be retained.

Buildings 1, 6, 7, 14, 15 & 16 are derelict and/or inappropriate or beyond economic repair and will be demolished. The masonry base to Building 1 could be retained to form a semi-enclosed area, while the upper derelict timber structure is removed.

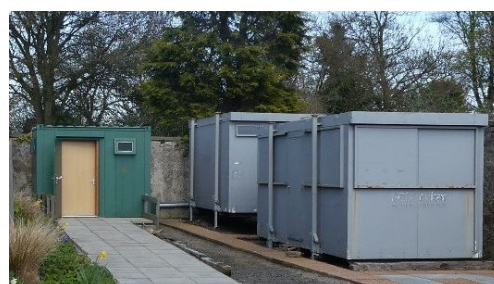
Fig.21: Toilet and Store containers

10 Greenhouse	–	This building has been demolished since 2010.			
11 Greenhouse	–	This building has been demolished since 2010.			
13 Shed	10m ²	Derelict and should be removed.			
14 F.C. Store	100m ²	This building is inaccessible and unused.			
15 W.C.	5m ²	Converted container providing toilet facilities.			
16 Store	5m ²	Metal container currently disused.			
17 G.K. Shed	10m ²	Timber shed facilities for Greener Kirkcaldy

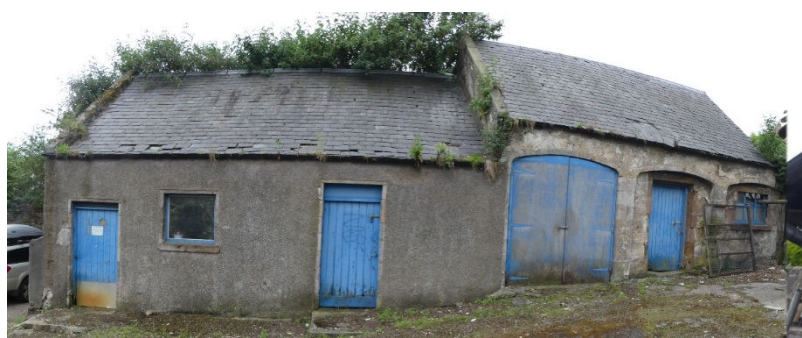
Fig.23: Building 3 – historic outbuilding

Table 3d: Known Hazardous Conditions				
<i>No.</i>	<i>Risk</i>	<i>Description</i>	<i>High</i>	<i>Low</i>
1	Hazardous Buildings	Entrance Buildings 3 & 4 present a significant danger of falling material and are currently publicly accessible. There is significant risk of damage heritage value.		
2	Hazardous Buildings	Building 9, the Victorian Greenhouse, presents a danger of falling material, but is largely inaccessible to the public. There is some risk of damage heritage value.		
3	Hazardous Buildings	Buildings 1 and 5 are derelict and dangerous, but are largely inaccessible to the public. There is some risk of damage to heritage value.		
4	Hazardous walls	All the walls present a minor risk of falling material, both within and outside the public realm.		
5	Hazardous Services	The condition of the exposed electrical and gas services is poor, though these supplies are understood to be disconnected. These are in public areas.

1. ***Repairing key historic elements:*** The listed boundary walls, Buildings 3 and 4 should be repaired with appropriate materials and brought into good order.
